SERVICE INFORMATION LETTER

Subject: Incorrect Part marking of Wencor ATS Seal Assembly

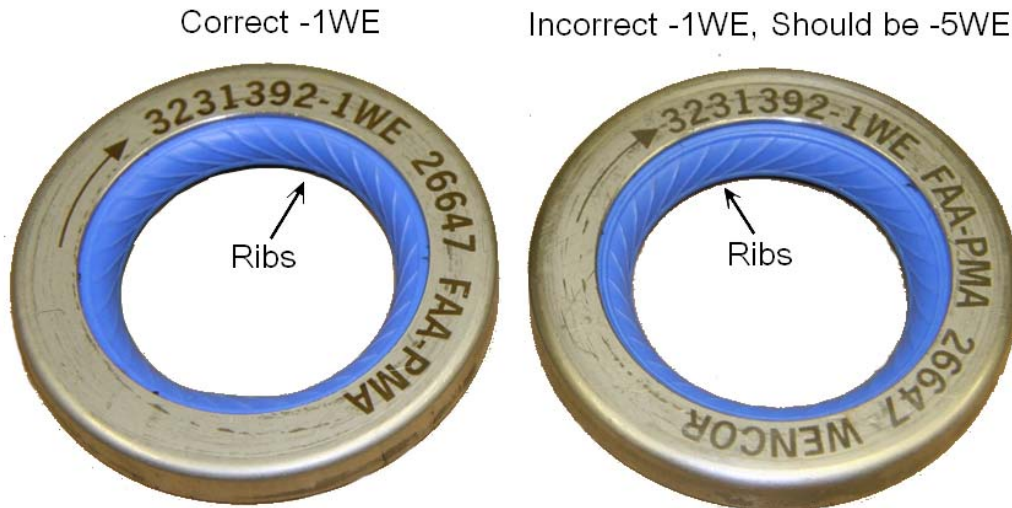
Figure 1, Rib Configuration

A single manufacturing lot of the Wencor Seal Assembly PN 3231392-1WE was manufactured with the directional ribs configured to match PN 3231392-5WE, but was marked incorrectly as PN 3231392-1WE. The -1WE and the -5WE are identical except for the rib configuration as shown in Figure 1.

Oil leakage due to the misidentified Wencor Seal Assembly may cause accelerated wear of the ATS. This condition does not affect aircraft safety.

For ATS serviced after December 2011 verify that the correct Seal Assembly rib configuration is installed (see Figure 1). If not, remove and replace the Seal Assembly with the correct one per the instructions in the ATS CMM. Return the misidentified Seal Assembly to Wencor. Record accomplishment of this SIL in the ATS overhaul log book.

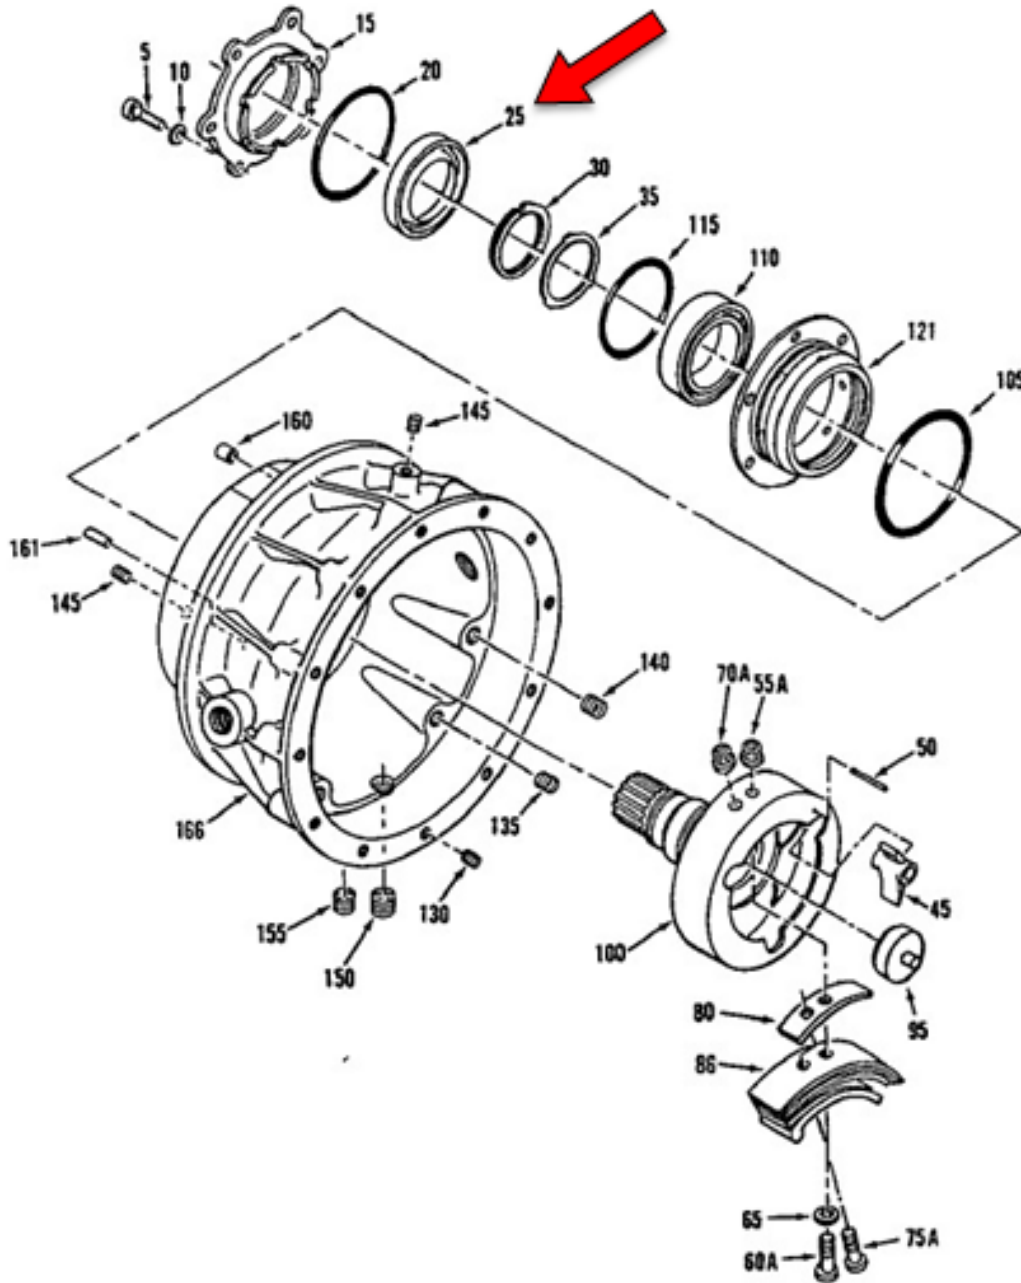
Figure 2, Installed Seal Assembly

The Seal Assembly is designed to prevent oil leakage from the output shaft chamber of the Air Turbine Starter (ATS). The directional ribs are a product improvement designed to redirect oil back into the ATS as the output shaft rotates. It is possible that oil leakage might occur if the Seal Assembly with the incorrect rib configuration is installed. Signs of oil leakage can be observed by oil leaking from the output chamber. See example of installed Seal Assembly in Figure 2.

For ATS installed with the Wencor Seal Assembly after December 2011, visually inspect the ATS for signs of excessive oil leakage from the output chamber in accordance with the approved aircraft maintenance program that exceed the limits defined in the ATS CMM. If excessive leakage is found, remove and replace the ATS per the instructions in the AMM. Record accomplishment of the removal of the ATS as instructed per this SIL in the aircraft overhaul log book.
