# SERVICE INFORMATION LETTER

**Subject:** IGVA Sector Gear with Oversize D-Hole Creating Loose Fit with NHA

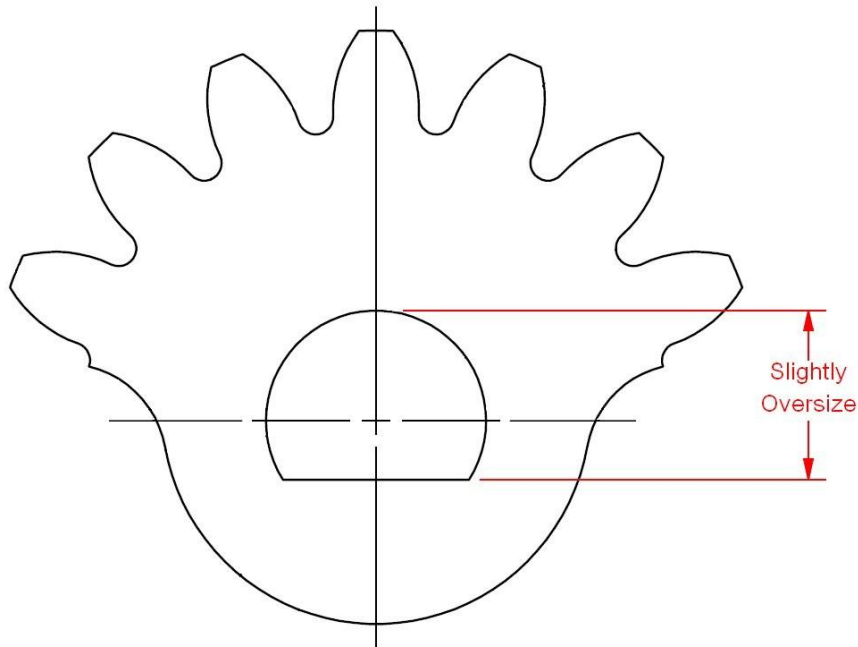
The D-shaped hole in the Wencor Inlet Guide Vane Assembly Sector Gear PN 3810119-2WE was manufactured oversize by .002” as shown below in Figure 1. The oversize condition will create a loose fit with the mating part and may lead to premature wear on the Inlet Guide Vane (IGV) stem, or other IGVA parts that operate in conjunction with the Sector Gear (see Figure 2).

**Figure 1, Sector Gear, Showing Oversize D-Shaped Hole**

Based upon a customer report of a tight installation problem, Wencor revised the Sector Gear design by adjusting the maximum D-shaped hole size up by .002" to prevent a possible interference condition with the mating IGV Vane stem. It was later discovered that the IGV Vane stem was the cause of the interference condition and the D-shaped hole size was re-designed larger than allowed per the OEM CMM. The re-designed Sector Gears were sold to customers and put into service.

For new Wencor Sector Gears that have not been installed, users can verify correct D-shaped hole size by measuring the hole as described in the OEM Component Maintenance Manual (CMM). Any Wencor Sector Gear D-shaped hole that is measured oversize shall be returned to Wencor for replacement.

For Wencor Sector Gears that have been installed, the user shall check the size of the D-shaped hole at the next shop maintenance/overhaul opportunity. Any Wencor Sector Gears that are within CMM limits can remain in service and any that are out of limits shall be removed and replaced according to the CMM.

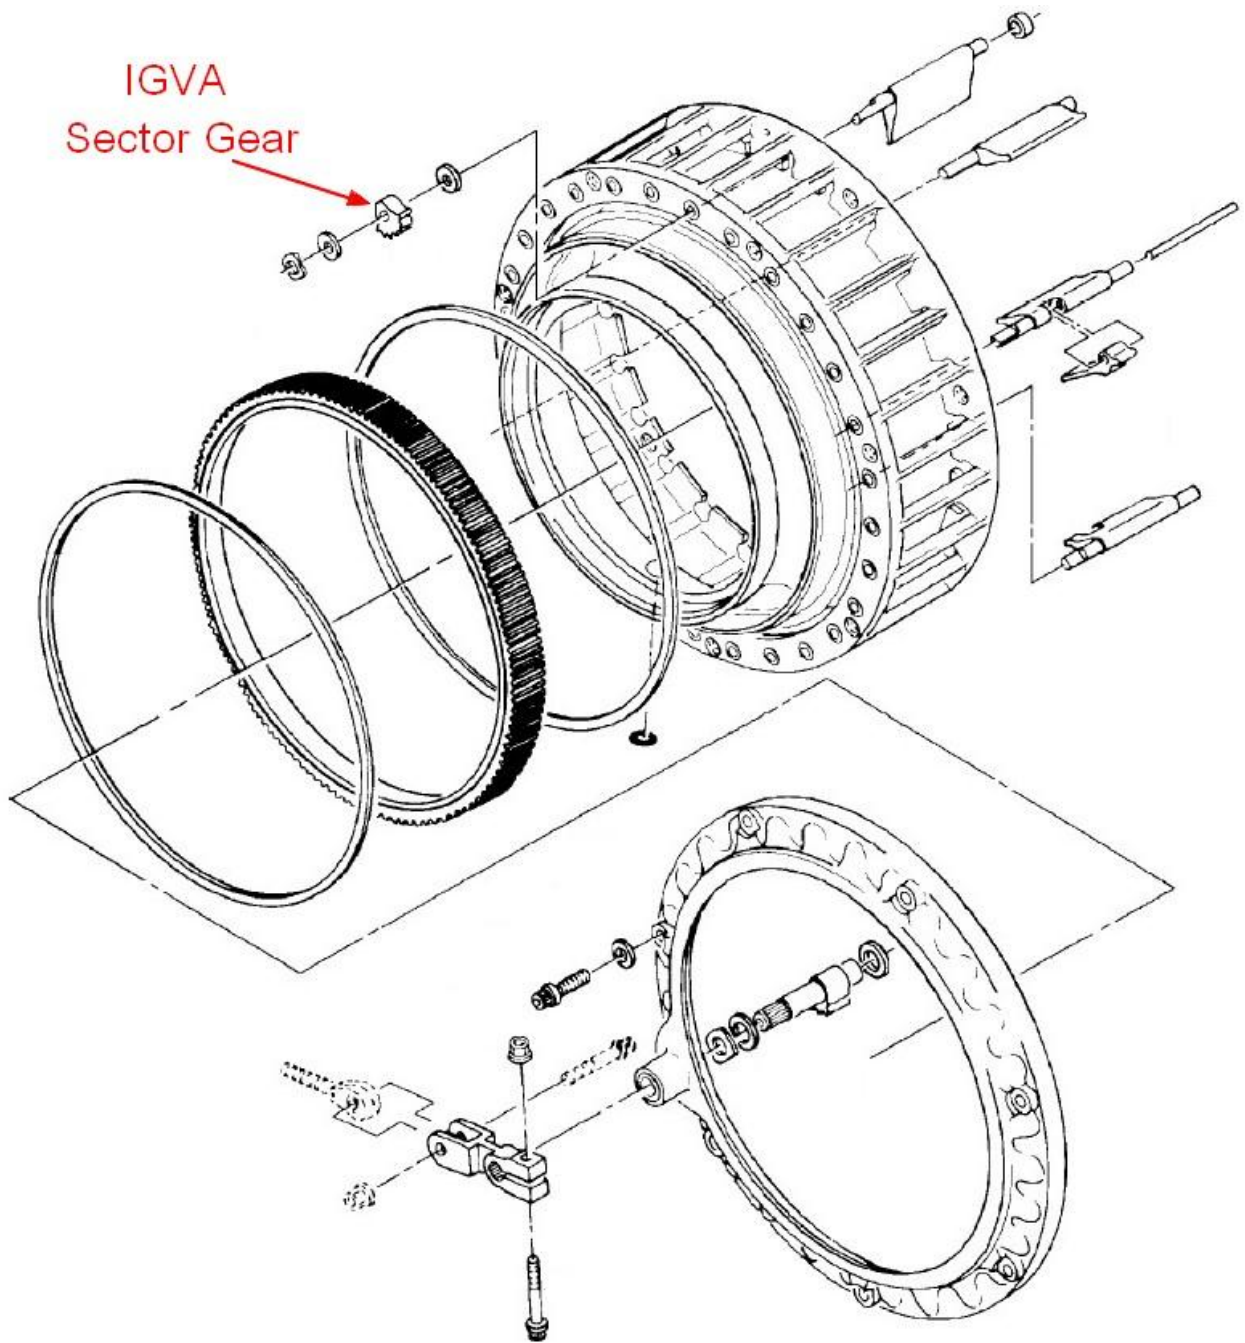
**Figure 2, Sector Gear Shown in the Inlet Guide Vane Assy**
