SERVICE INFORMATION LETTER

Subject: Nut PN 63-347WE having damaged or flawed threads

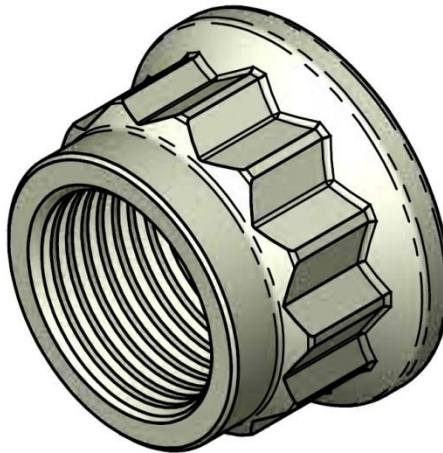
Figure 1, ISO View of Nut

A single Wencor customer reported that a small quantity (six) of Nuts was found to have damaged or flawed internal threads that prevented complete installation.

The flawed threads were caused from an excess build up of Cadmium plating during the manufacturing process. The excess plating prevented the full installation of the Nut, therefore the Wheel assembly could not be assembled until the Nut was replaced. Because the excess plating prevented installation, there is no in-service safety problem resulting from this issue.

Visually examine all Nuts that have not yet been installed for flawed internal threads or threads that appear to have an excessive build-up of CAD plating.

An alternate method to verify proper threads is to install the Nut onto the mating bolt. The Nut should freely turn onto the bolt until the locking feature is contacted, which is approximately 5 full turns.

Return all Nuts that have flawed threads per section 4 of this SIL.

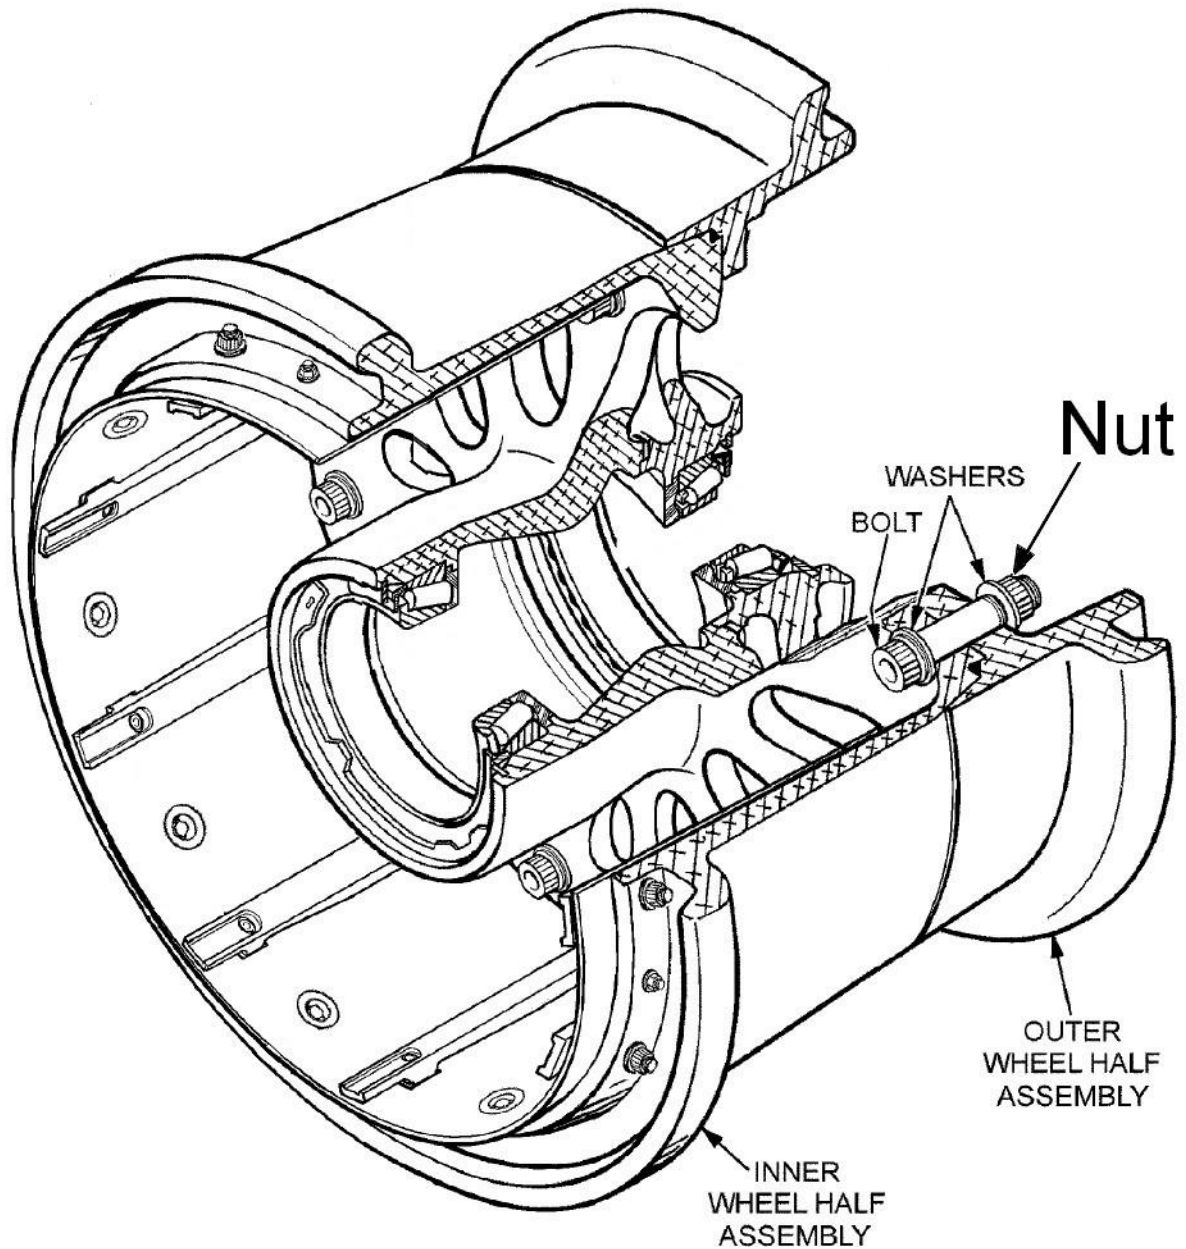
Figure 2, Installed Nut

The purpose of the subject Nut is to hold the two wheel halves together as shown in Figure 2 below. There are 18 Nuts, Bolts and Washers that are used together for this purpose.

During the installation process, the Nuts with the flawed internal threads were discovered. The flawed threads prevented the Nuts from fully installing onto the Bolts.
