SERVICE INFORMATION LETTER

SIL # 170706-738466-6WE

SUBJECT: Electrical Brushes were incorrectly manufactured with incorrect shape and/or cracks.

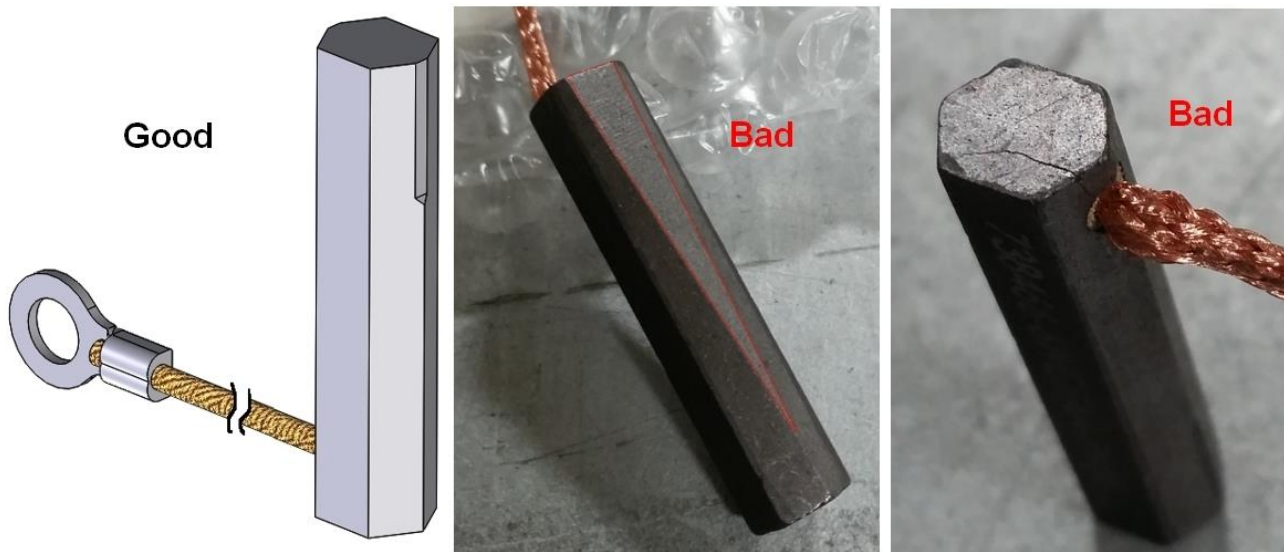
A single customer reported that a small quantity (2 out of 158) of Electrical Brushes had an incorrect shape and/or cracks near the shunt wire as shown in Figure 1.

Figure 1, Left Image shows correct Brush shape, Center Image shows incorrect shape (extra machined surface), Right Image shows crack.

A manufacturing error caused the incorrect shape (extra machined surface) and the crack near the shunt wire location.

If the cracked Electrical Brush was installed and passed the NHA CMM testing, there would be only minor effects on the operational safety of the aircraft due to the redundancy of the system, which includes 6 or 8 Electrical Brushes. The cracked Brush may transfer less electrical current to the propeller de-icing system, but the other non-damaged Brushes would carry the proper electrical current in the propeller de-icing system. However, there is a potential for reduced long-term reliability in the propeller de-icing system due to less current flow from the cracked Brush.

The incorrectly machined Brush will not have any effect on installation and will pass the NHA CMM testing. However, there is a potential for reduced long-term reliability in the propeller de-icing system due to the reduced cross-sectional area of the Brush.

Any Wencor Electrical Brush PN 738466-6WE that was purchased from Wencor before July 2016 that has not been installed and put into service should be inspected for the conditions described in this SIL and if confirmed, the Brush should be returned to Wencor per section 4 of this SIL.

Any Wencor Electrical Brush PN 738466-6WE that has been installed into the NHA unit and passed the required CMM testing may remain in service at the discretion of the end user by following the normal instructions for continued airworthiness of the propeller de-icing system.

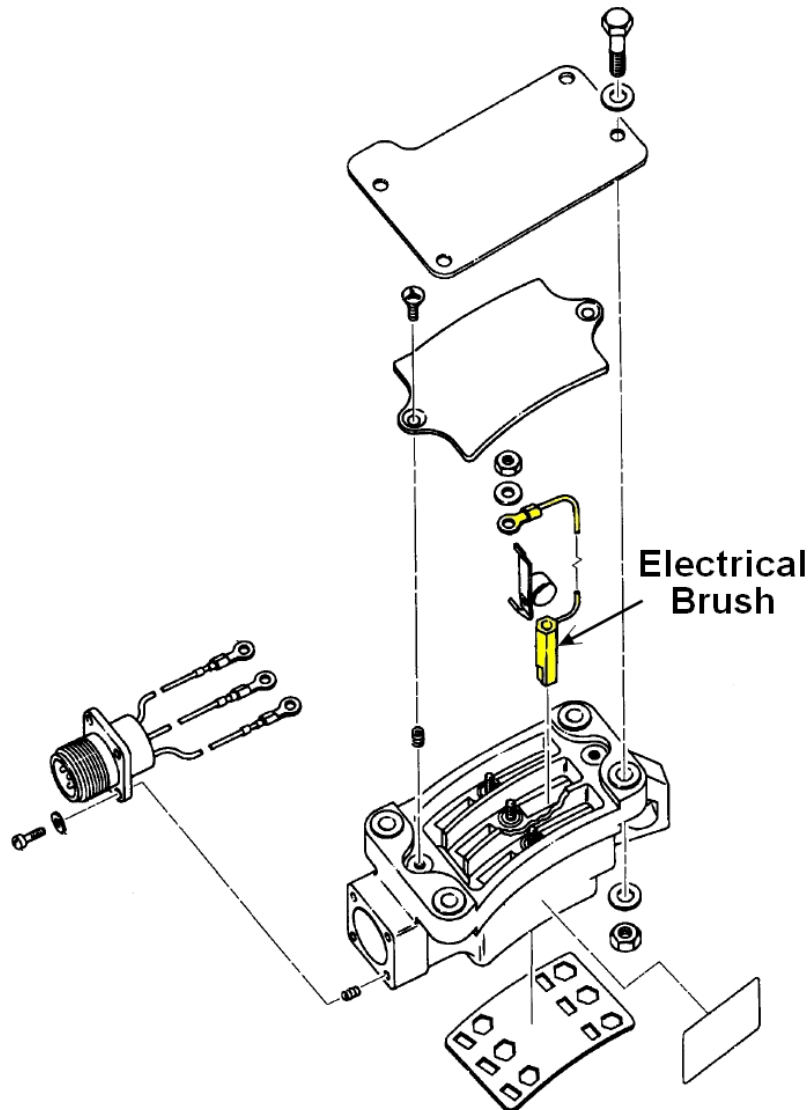
The Electrical Brush is installed into the NHA and is used to transfer electrical current to the rotating propeller for de-icing, see Figure 2 below.

Figure 2, Electrical Brush (qty 6) Installed into Brush Block Housing Assy
